AFML-TR-76-173

## EXPLORATORY DEVELOPMENT ON DURABILITY OF ADHESIVE BONDED JOINTS

BOEING COMMERCIAL AIRPLANE COMPANY  
P.O. BOX 3707  
SEATTLE, WASHINGTON 98124

TECHNICAL REPORT AFML-TR-76-173  
FINAL REPORT FOR PERIOD FEBRUARY 1974 - OCTOBER 1976

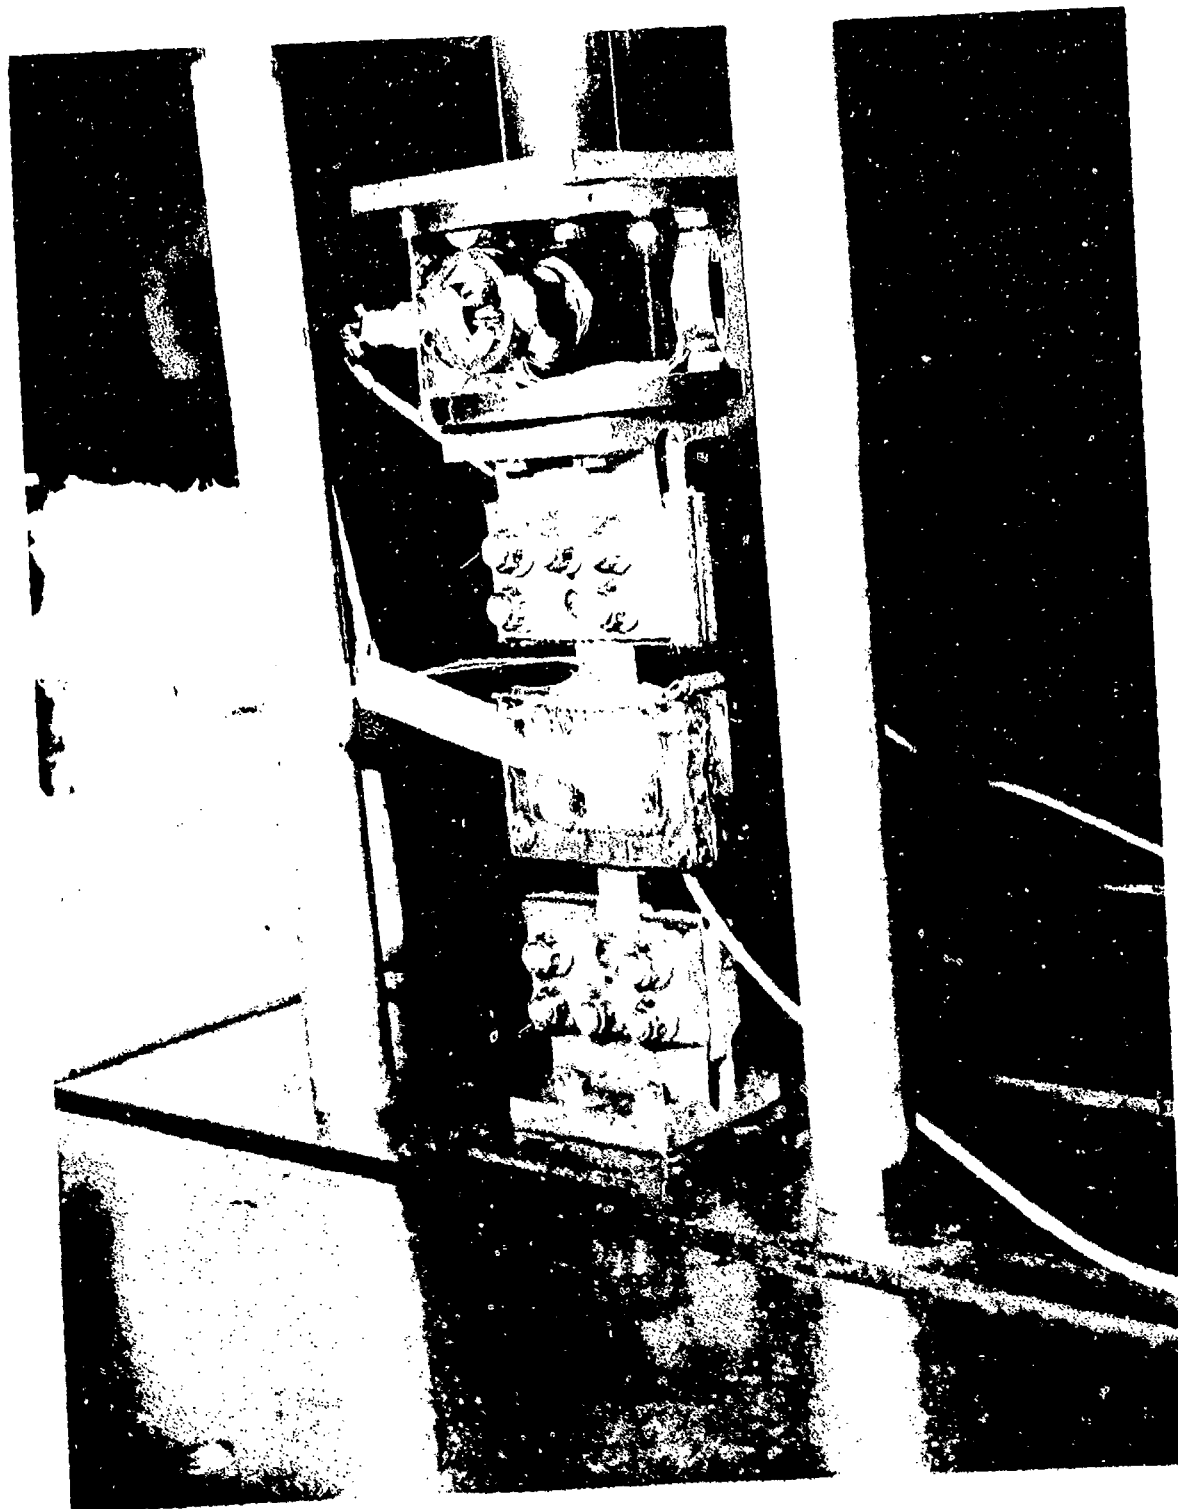
*Figure 24.—Fatigue Test Arrangement for Thick-Adherend Lap-Shear Specimens  
(Environmental Chamber Surrounds the Specimen.)*

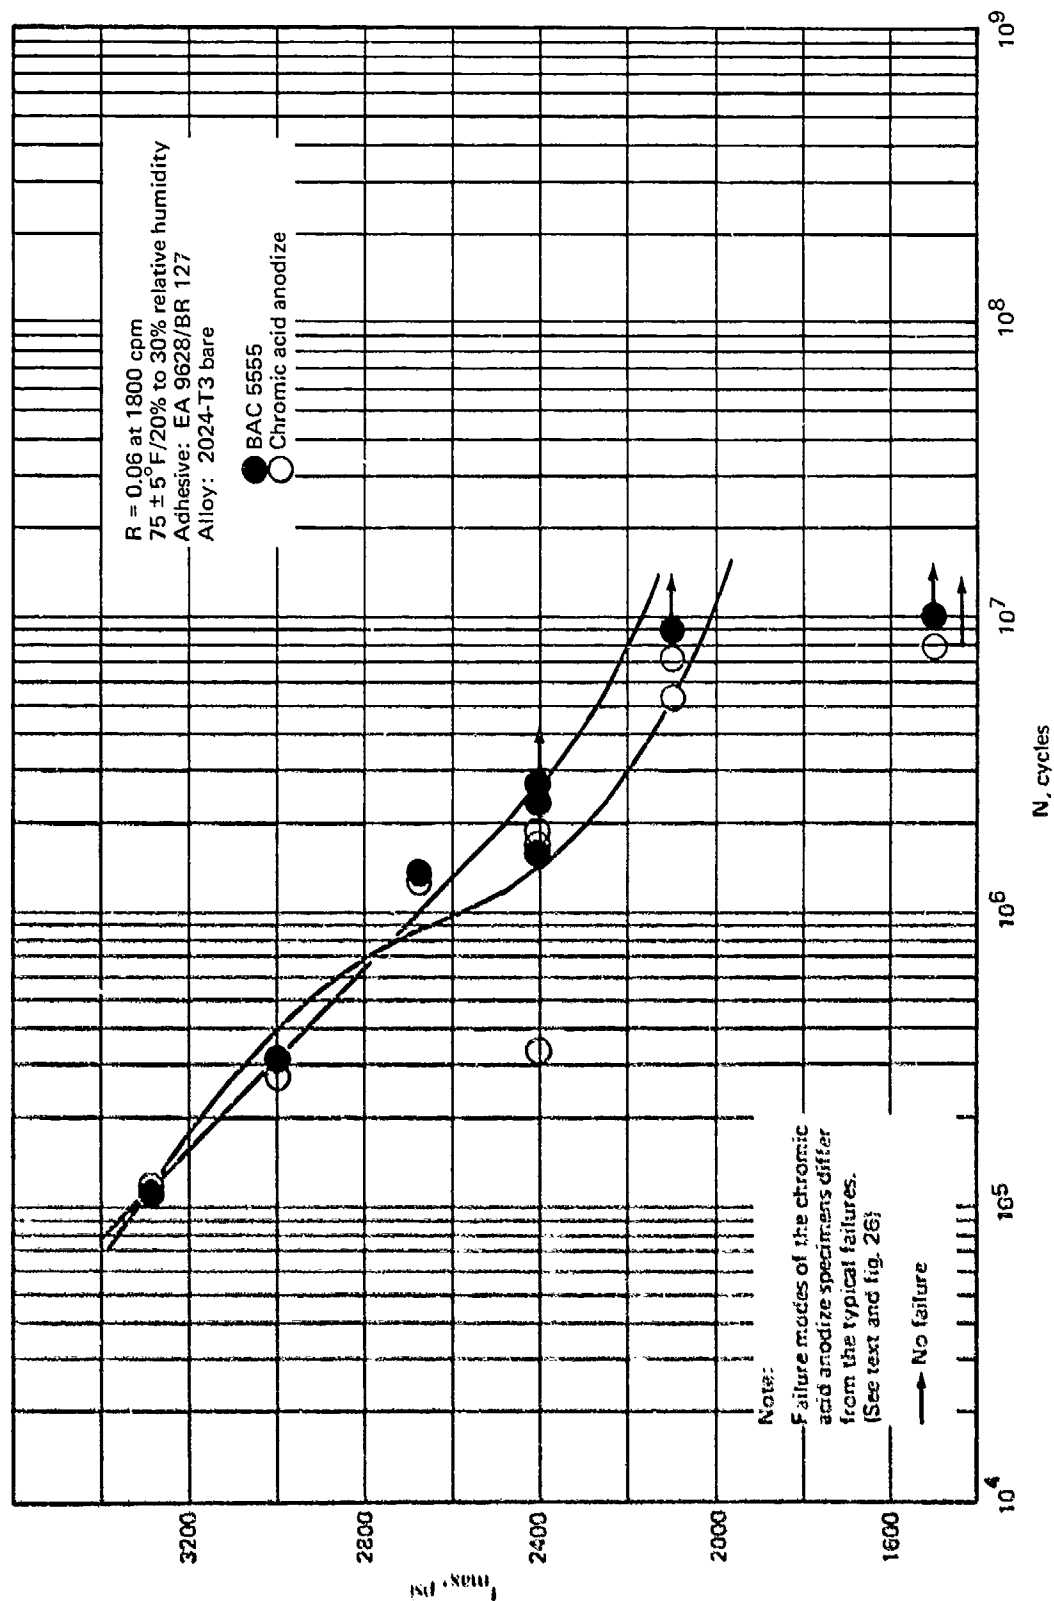
(a) 75°F Dry Environment

Figure 25.—Fast Cycle Stress Results

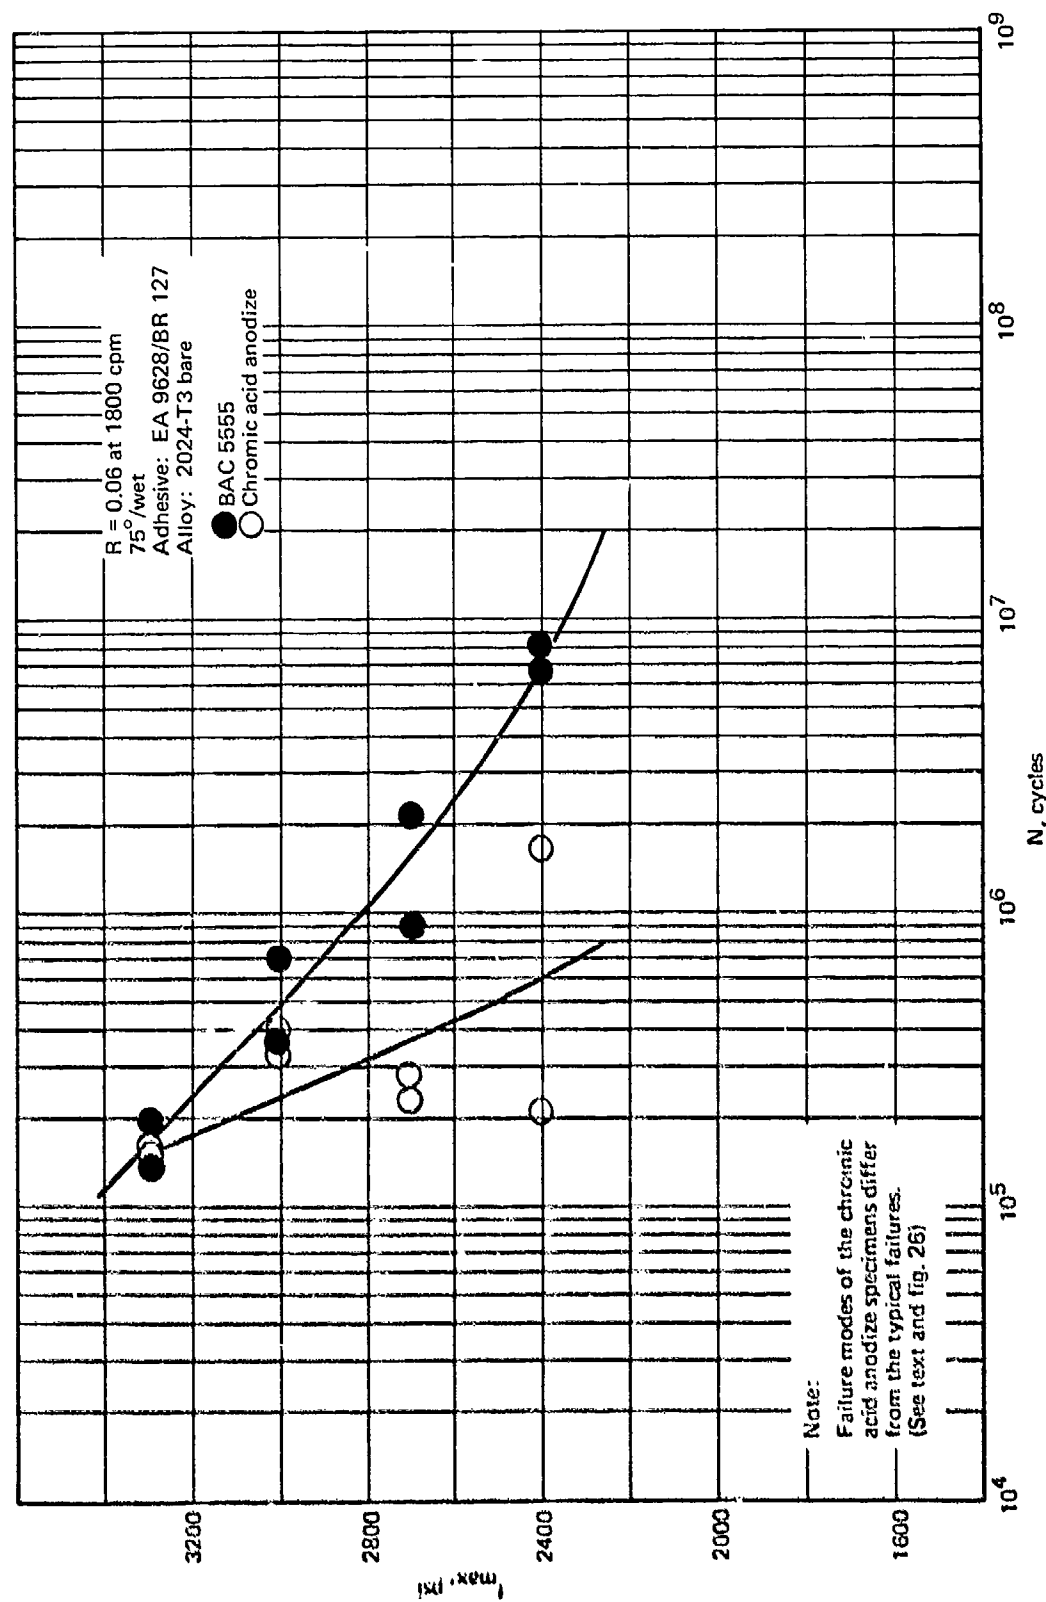
(b) 75°F Wet Environment  
 Figure 25. — (Continued)

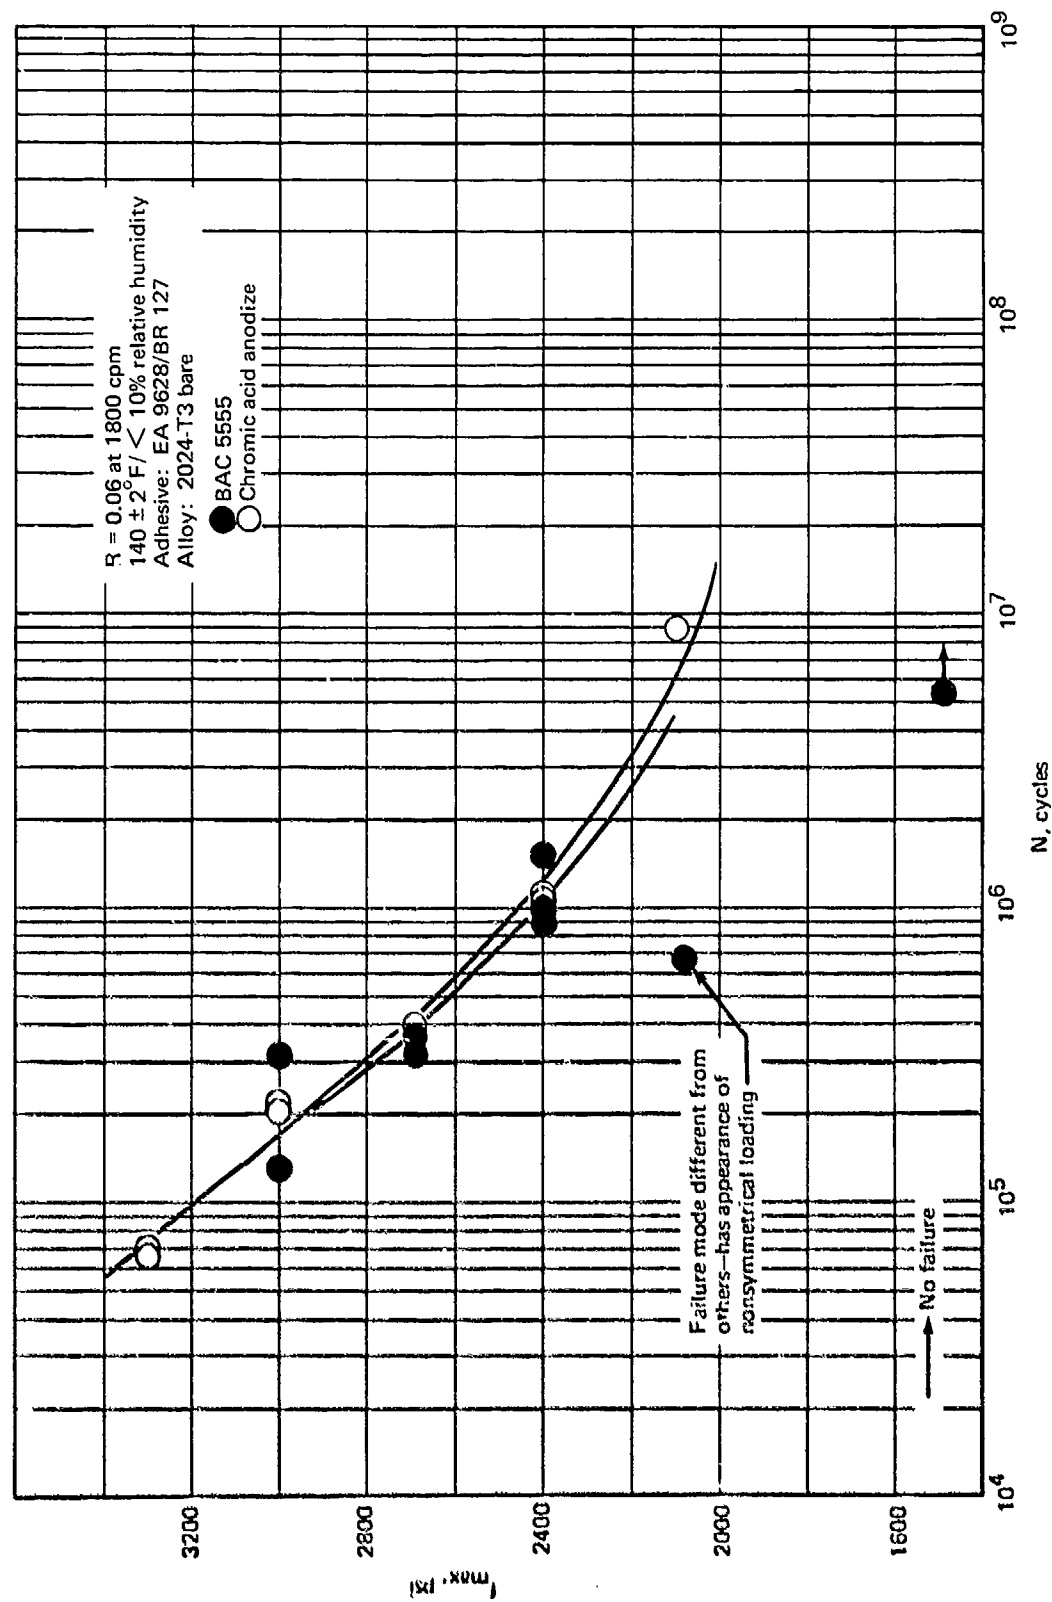
(c)  $140^\circ\text{F}$  Dry Environment  
 Figure 25.—(Continued)

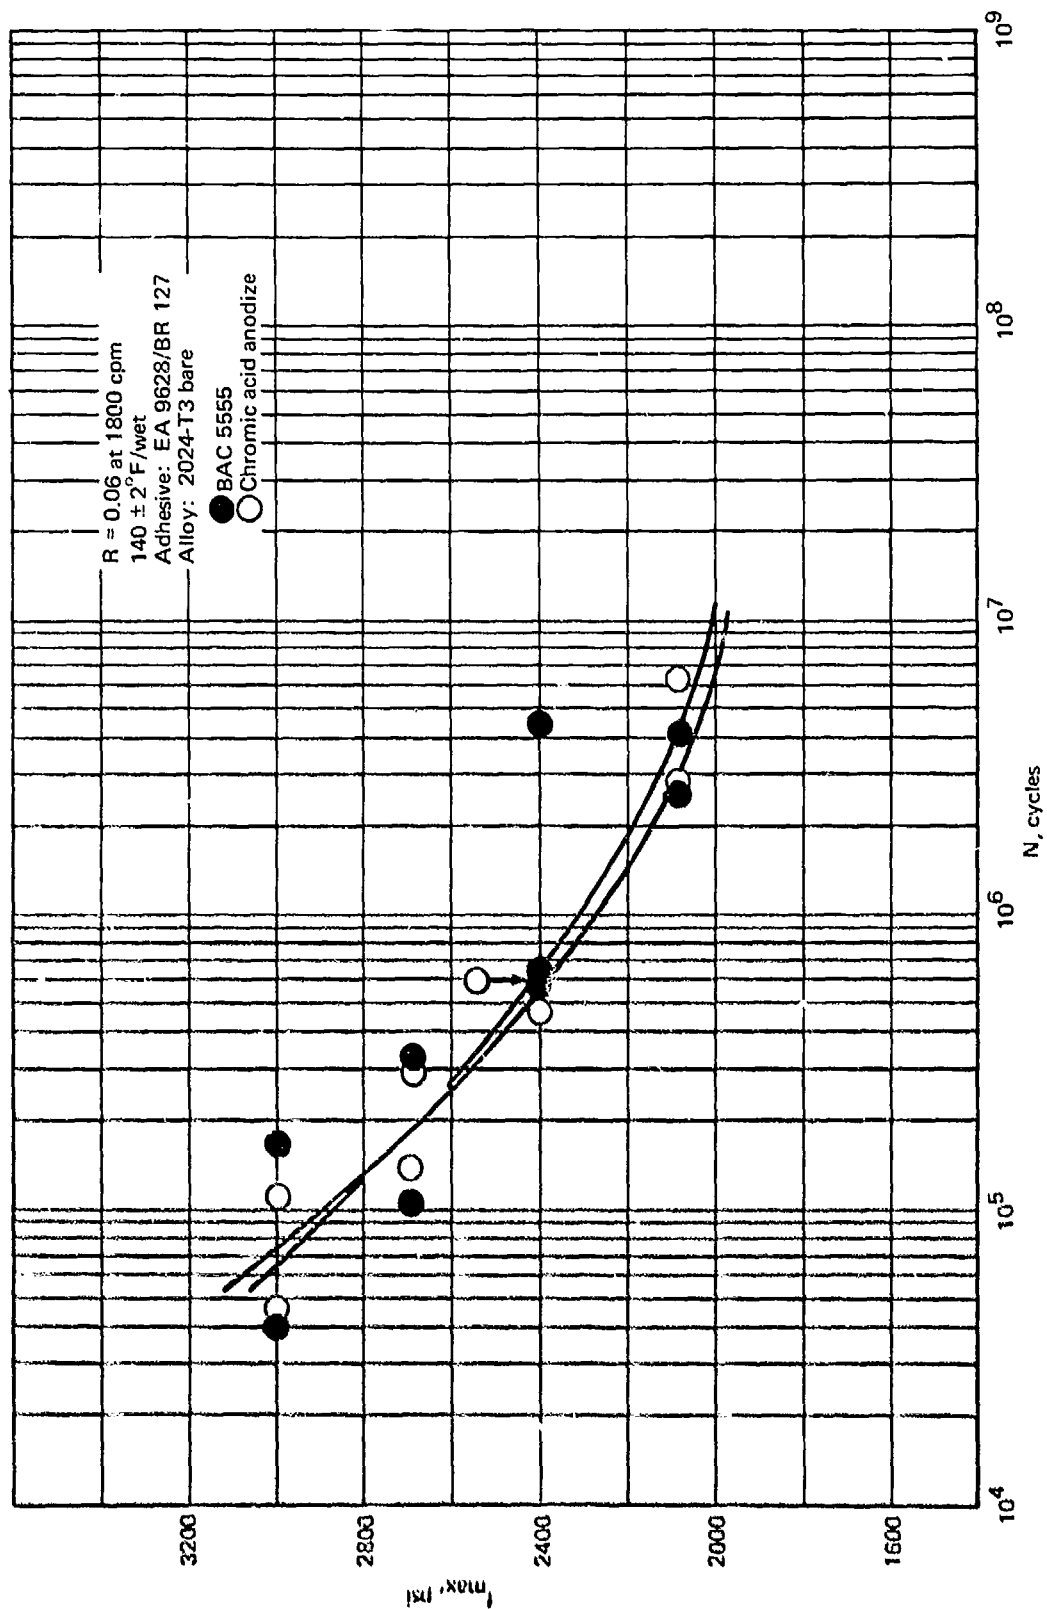
(d) 140°F Wet Environment  
Figure 25.—(Continued)

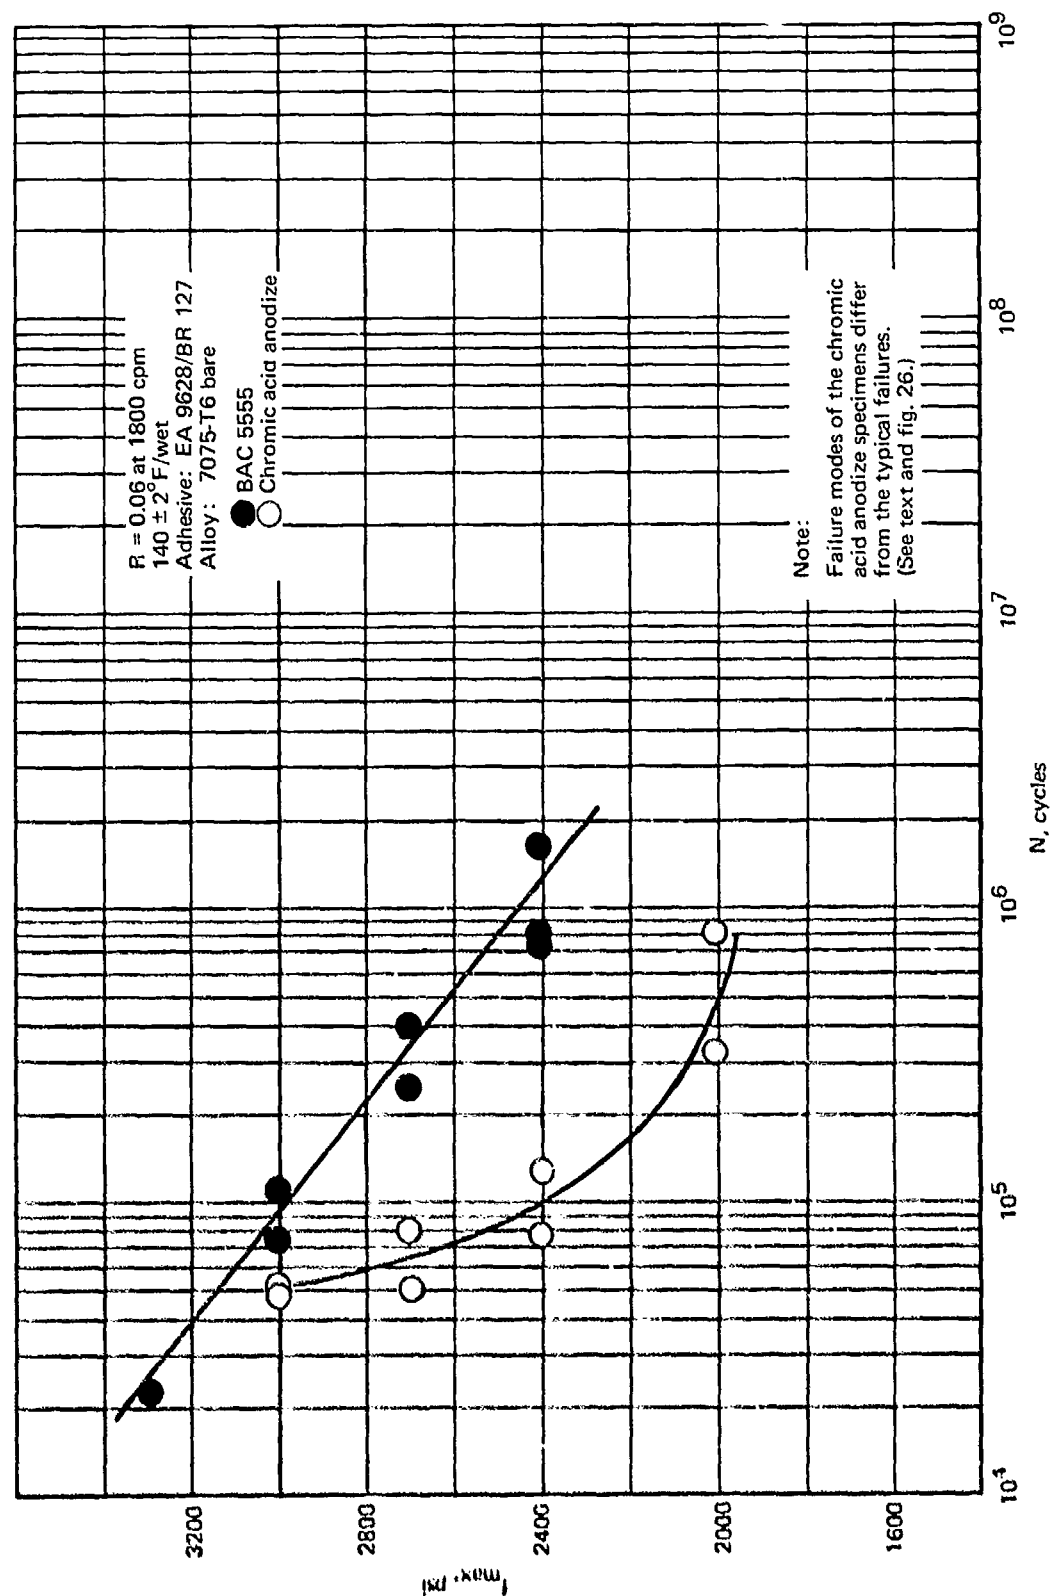
(e)  $140^\circ\text{F}$  Wet Environment, 7075-T6 bare

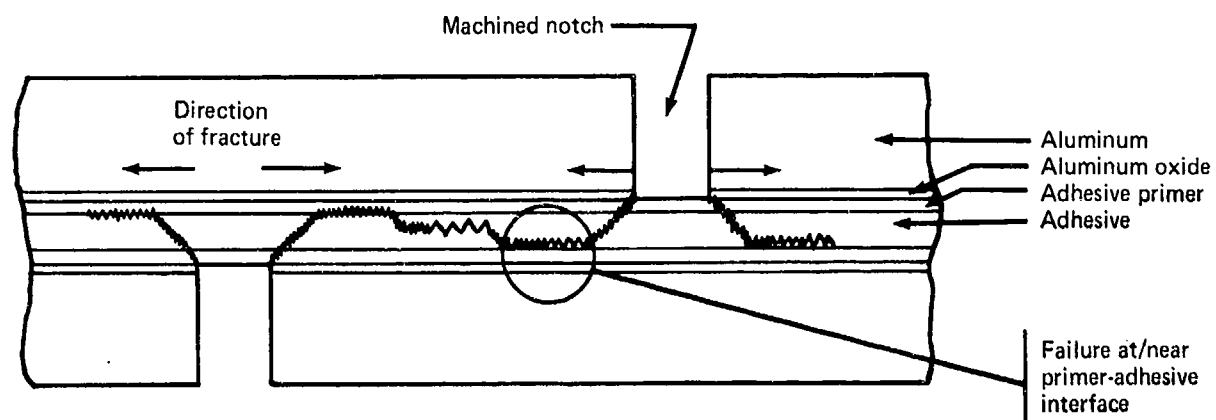
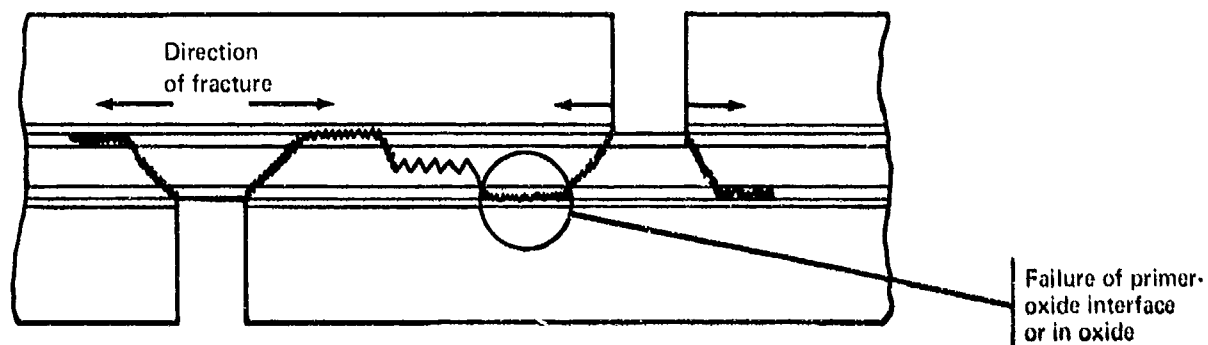
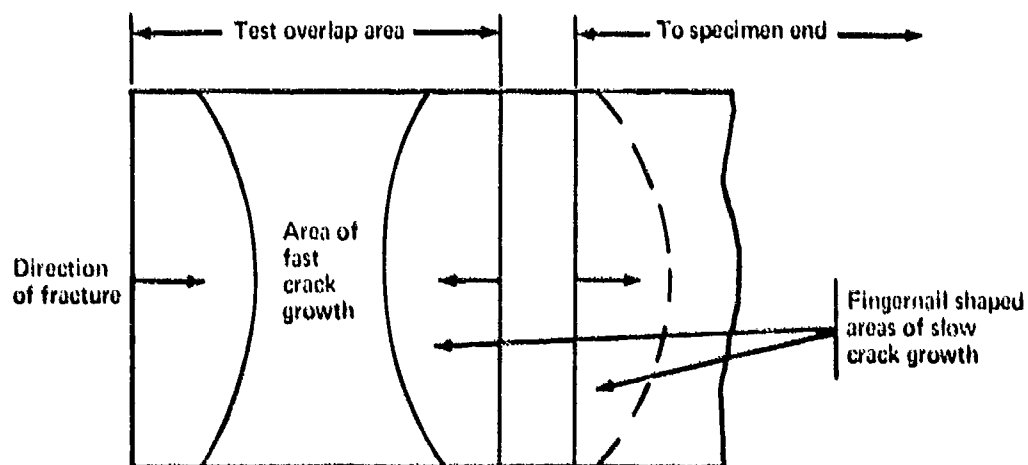
(a) Side View of "Typical" Failure

(b) Side View of "Adhesive" Failure

(c) Top View of Fracture Surfaces

Figure 26.—Failure Mode Characteristics of Thick Adherend Lap Shear Specimens Tested at 1800 cpm,  $R = 0.06$ .

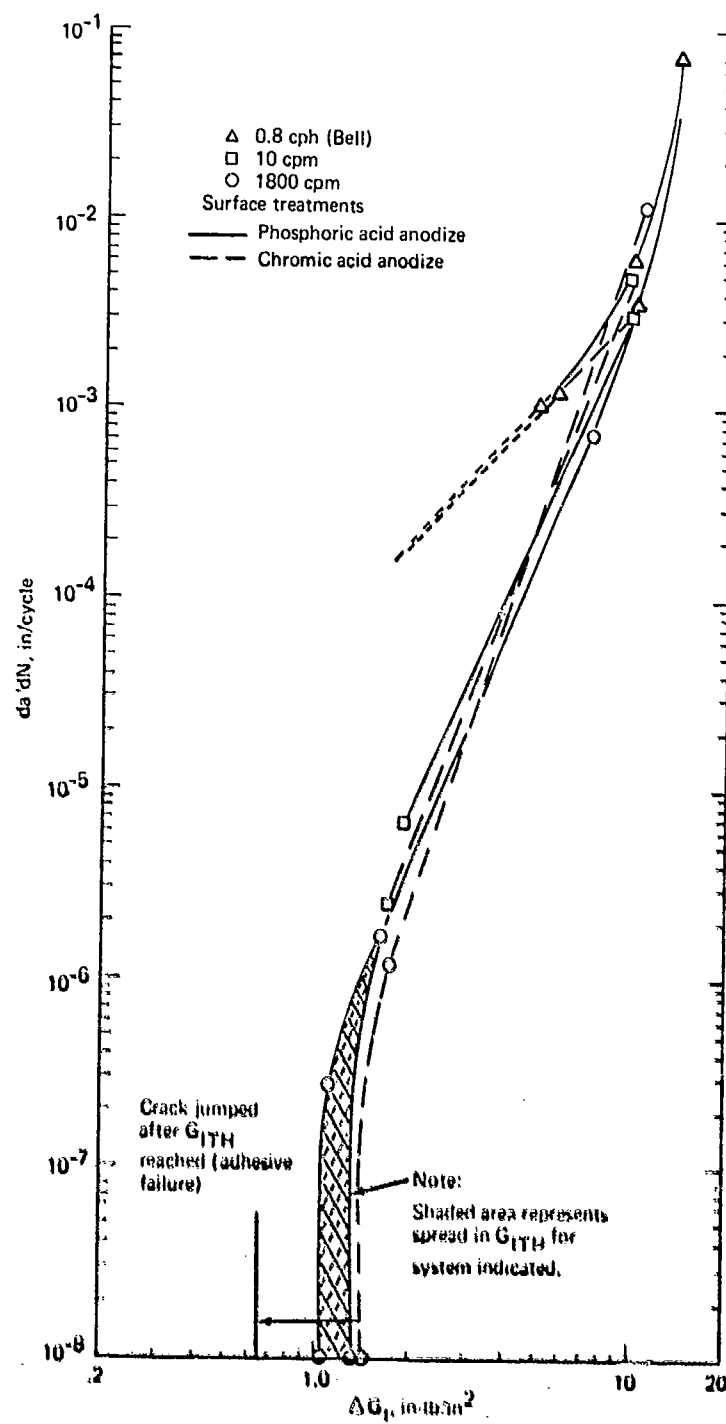
(a) Specimens Tested at Room Temperature, Humidity < 50%, EA 9628/BR 127, 2024-T3 Bare

Figure 31.—Cyclic Crack Growth Rate Data

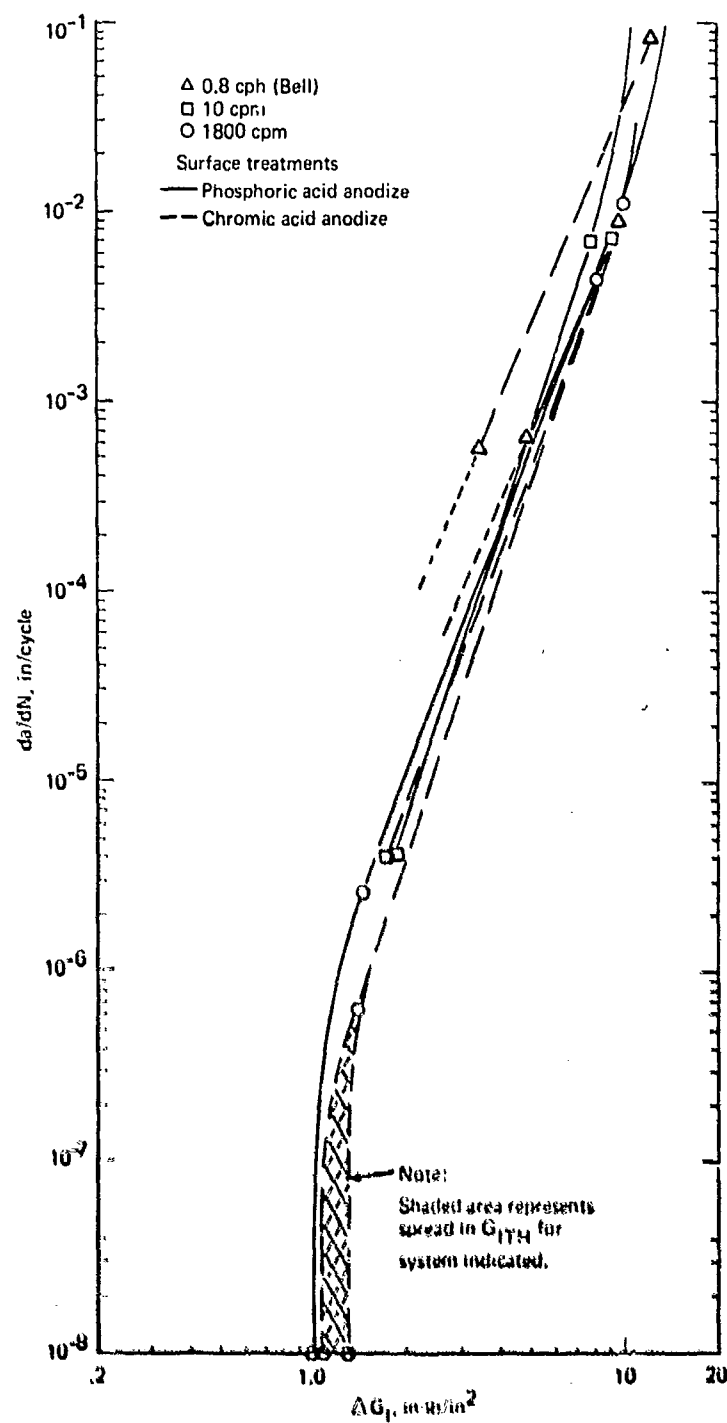
(b) Specimens Tested at Room Temperature, Wet, EA 9628/BH 127, 2024-T3 Bare

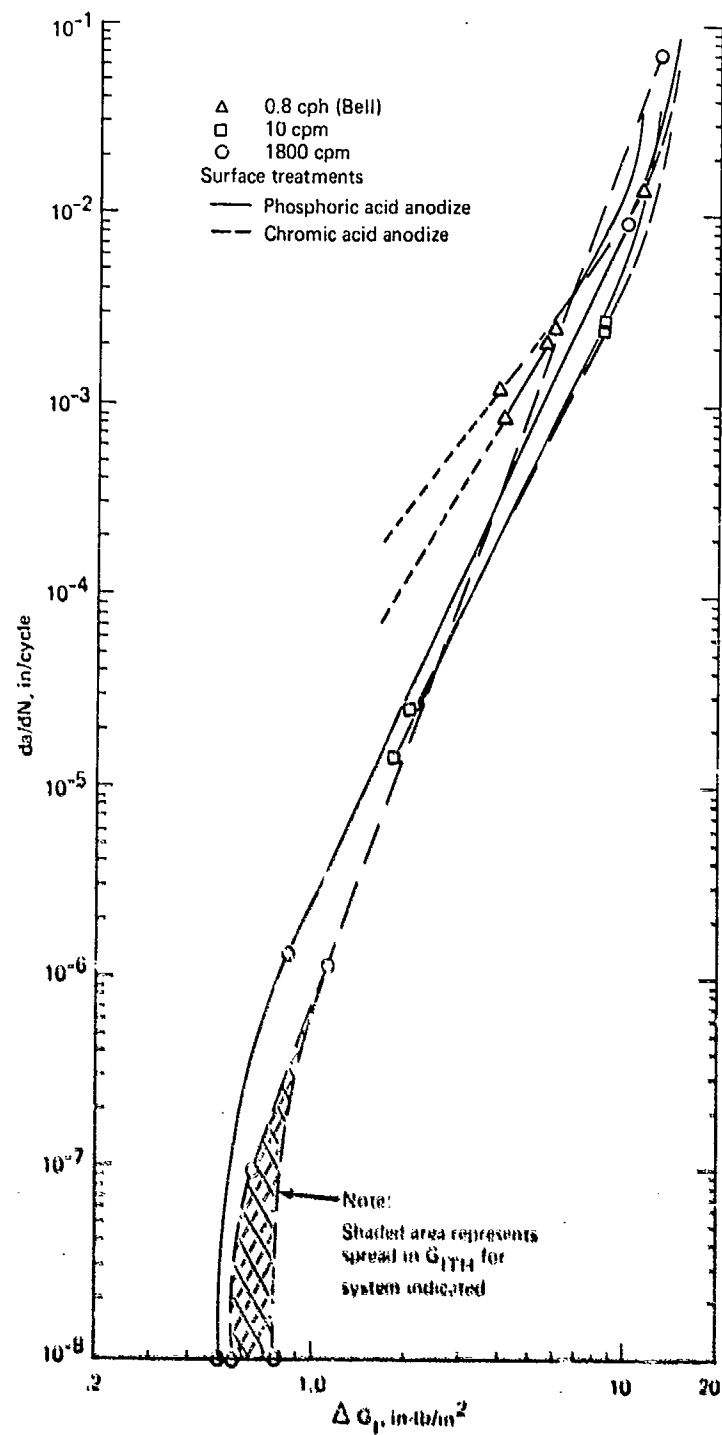
(c) Specimens Tested at 140°F, Dry (<20% RH), EA 9628/BR 127, 2024-T3 Bare

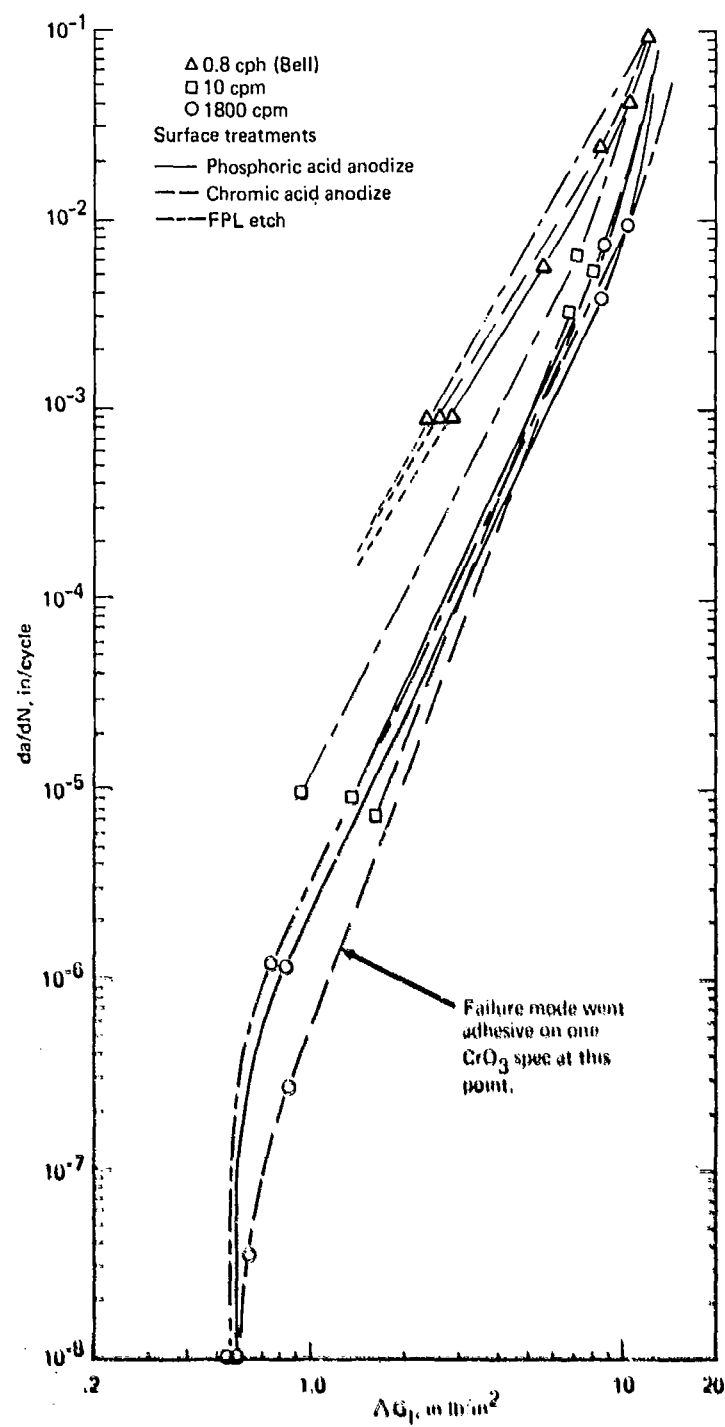
(d) Specimens Tested at 140°F, Wat, EA 9628/BR 127, 2024-T3 Bar

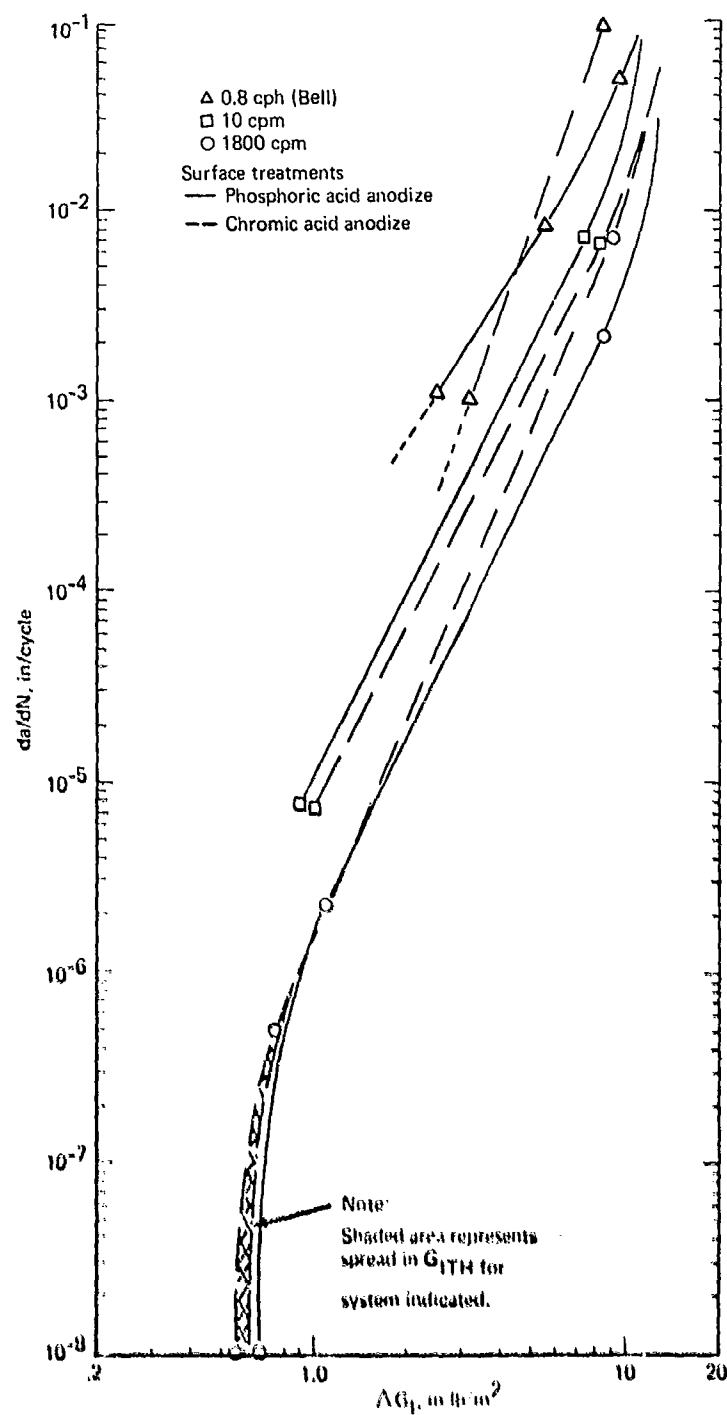
(e) Specimens Tested at 140°F. Wet, EA 9628/BR 127, 2024-T3 Bare

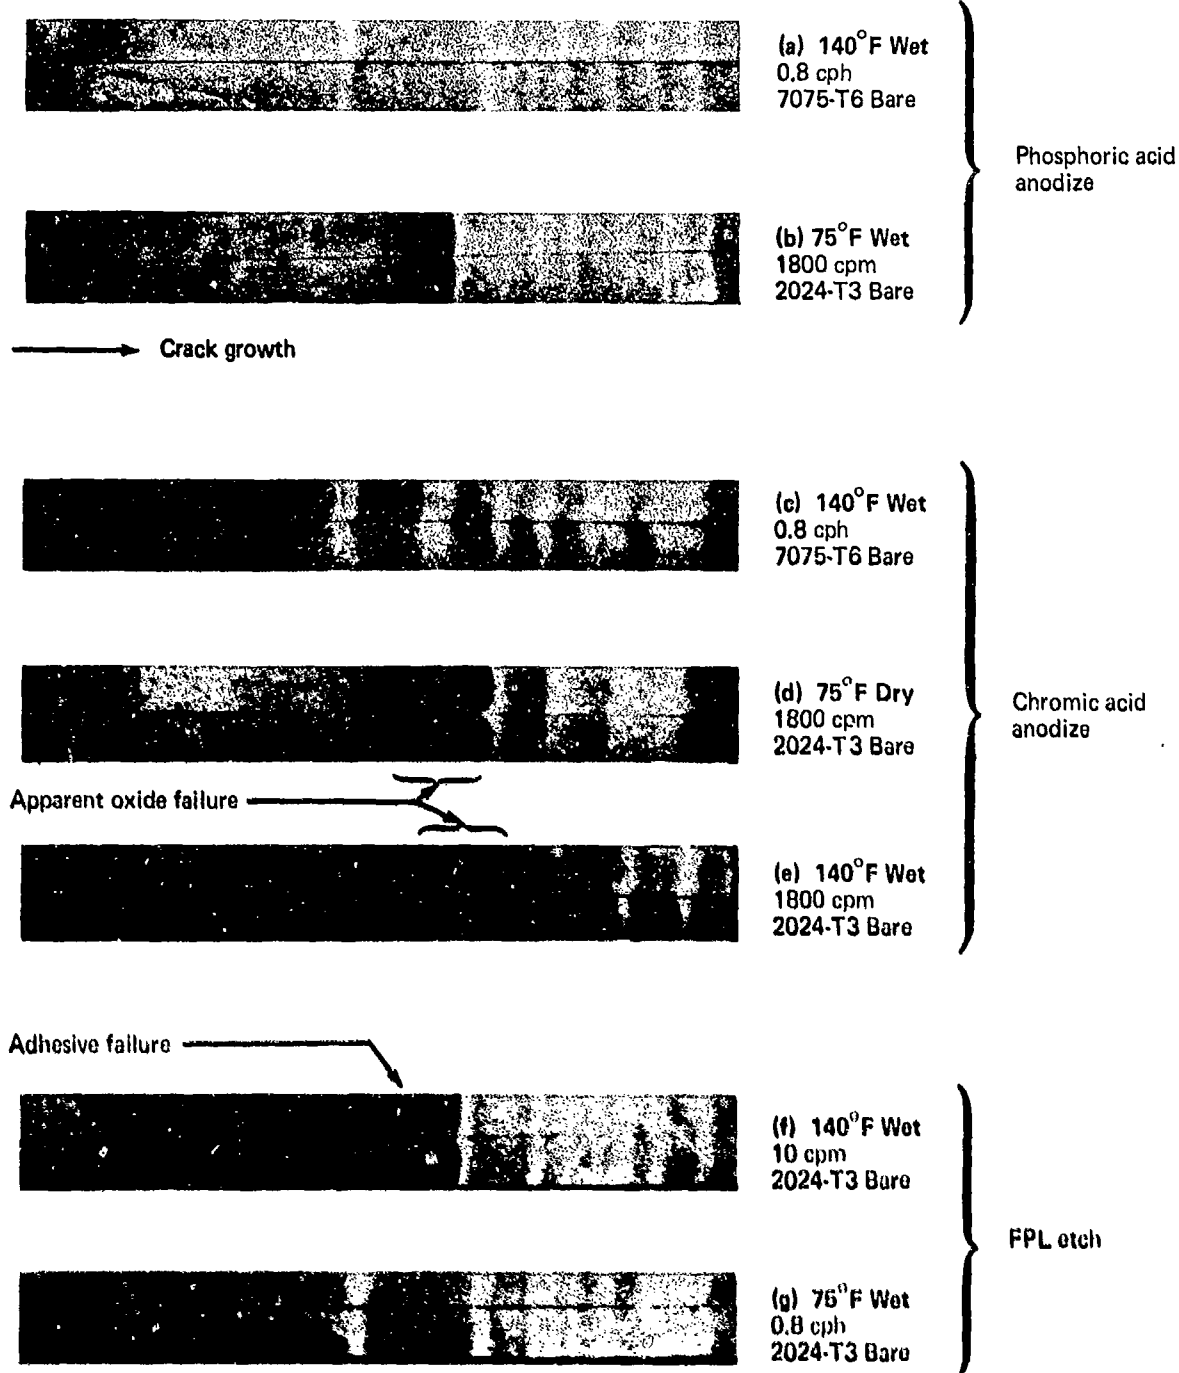
Figure 32.—Fracture Appearances From Cyclic Loading of DCB Specimens  
EA 9628/BR 127 Adhesive Primer System.

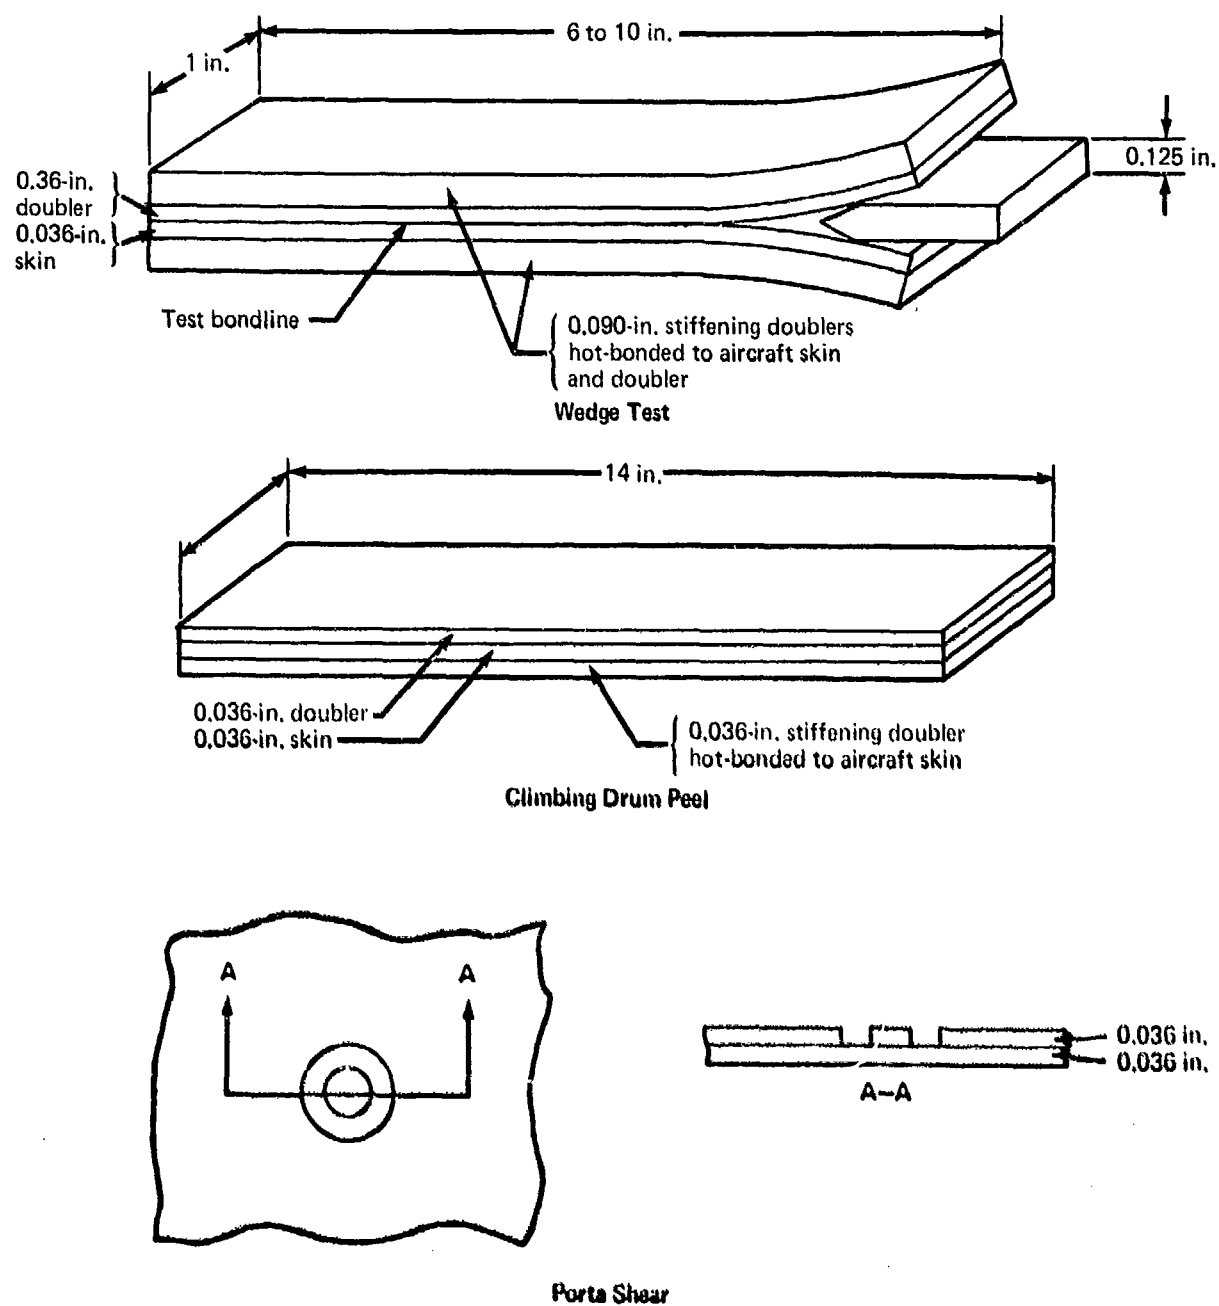
Figure 36.—Specimen Configuration for Commercial Aircraft C

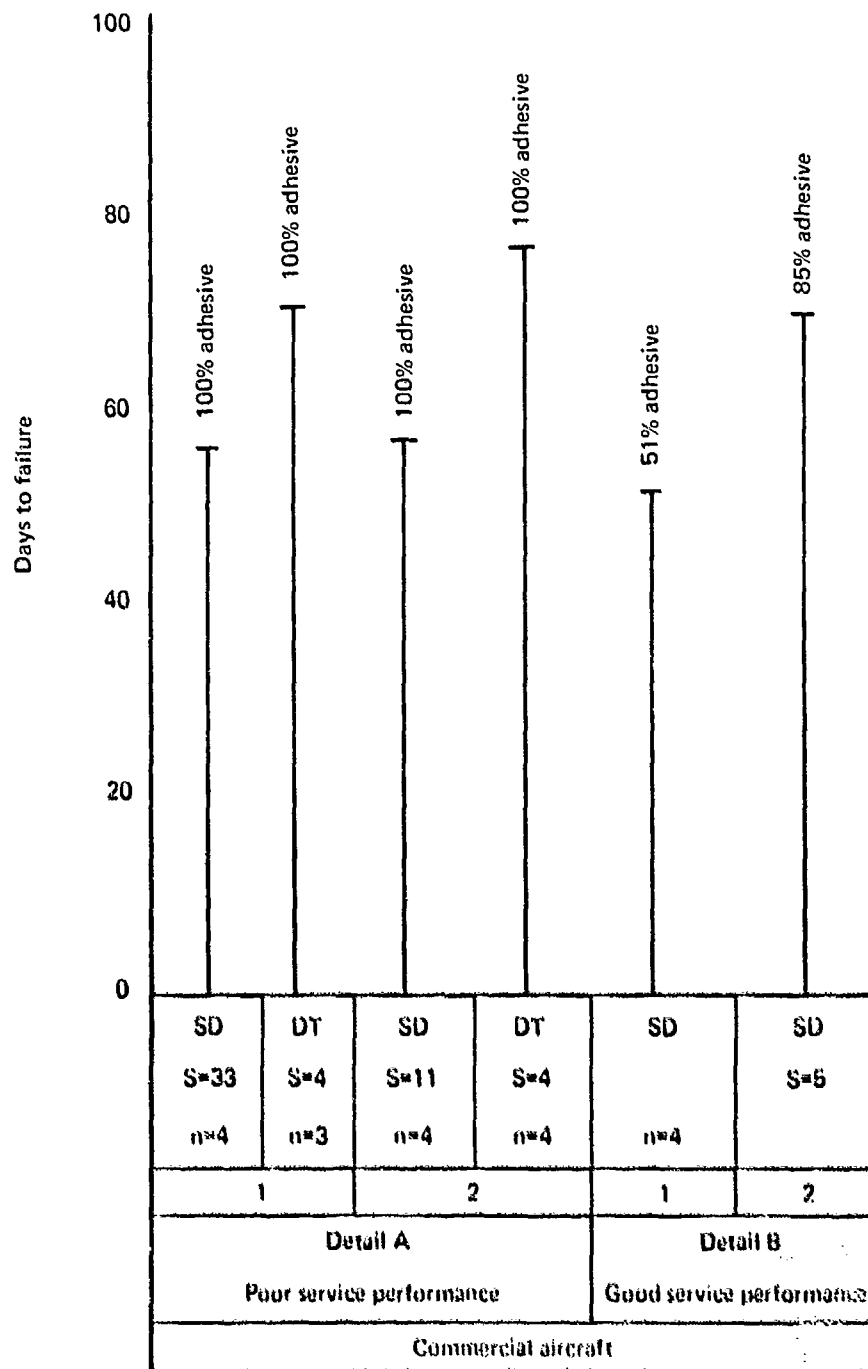
Environment: 140°F/condensing humidity

Figure 38.—Sustained-Stress Lap-Shear Results of Specimens Machined From Aircraft A and B Components

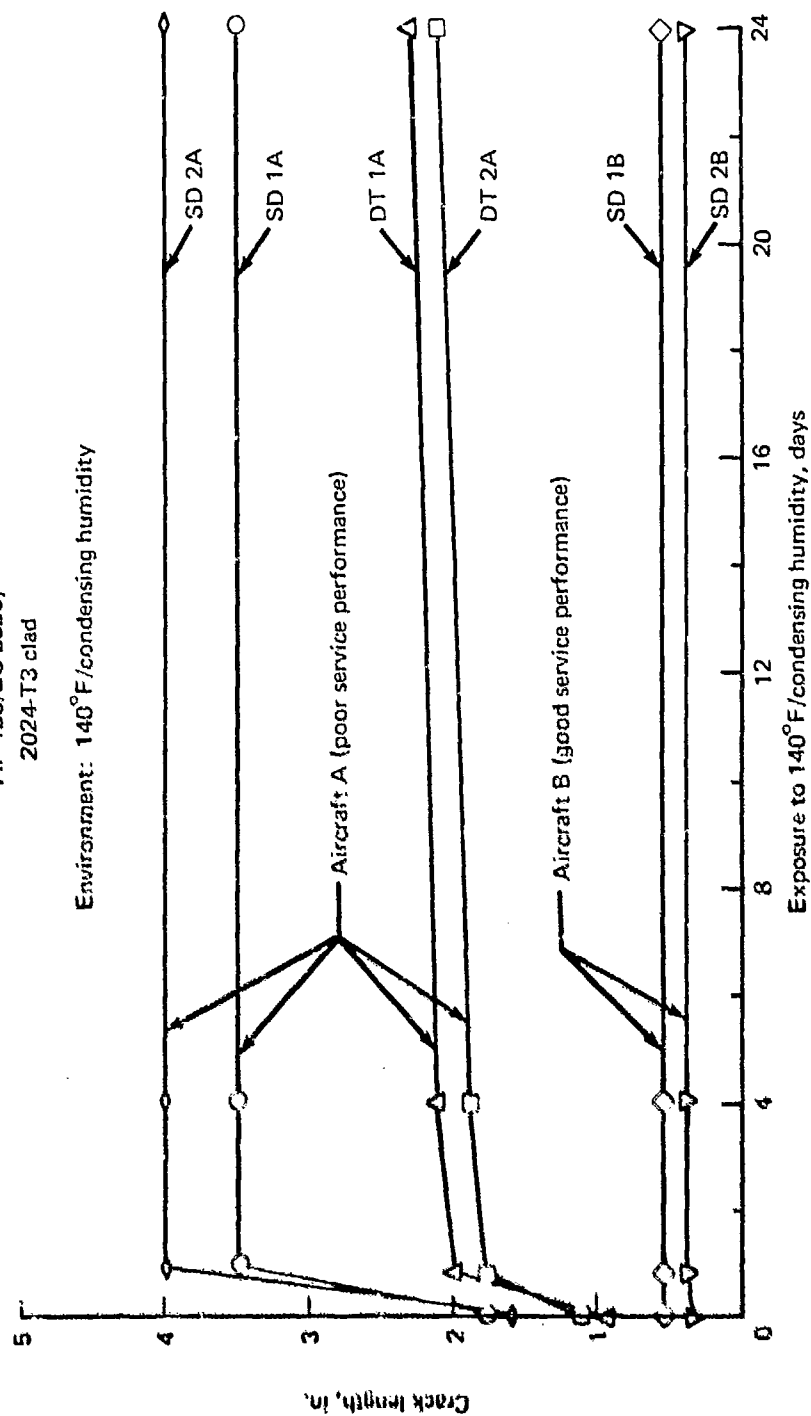
AF 126/EC 2320,  
2024-T3 clad

Environment: 140°F/condensing humidity

Figure 39.—Wedge Test Results of Specimens Machined From Aircraft A and B Components
